Systematic Home Inspections, PLLC

PROPERTY INSPECTION REPORT

Concerning: Confidential - McKinney, TX 75069

9/1/2010

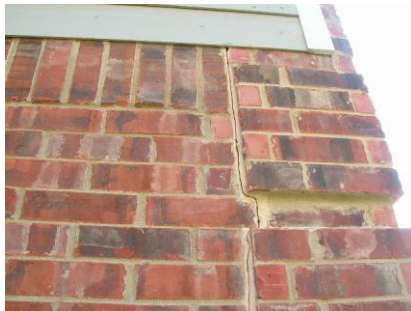
1

- Some signs of minor mortar separation less than ¼ inch wide in brick at Southwest corner of home. (pic 1)
- Areas of minor mortar separation around garage doors and upper part of front entry-way.
- Minor corner cracking observed in both rear corners of the slab. (pic 2 and 3)
- Signs of previous mortar repair above garage. (pic 4)
- Recommend areas of cracked and damaged mortar be monitored and evaluated by a specialist.

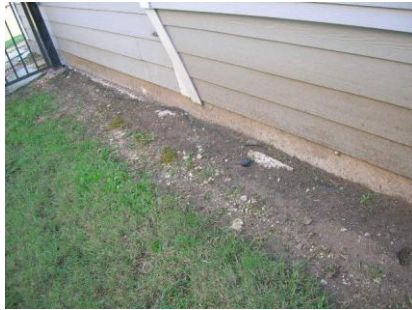
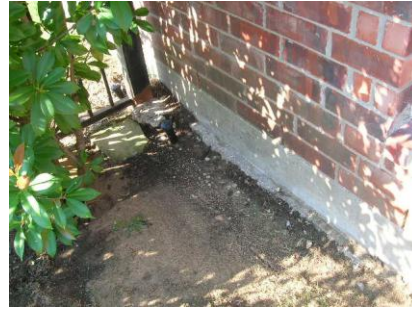
- Low areas of soil observed on both East and West sides of house. (pics 1&2)
- Recommend gutters be installed with downspouts directed away from foundation.

- Drip-line from rain coming off the roof is visible on the East and West sides of house. (pic 1 & 2)
- Recommend adding topsoil to low areas where the foundation is visible.

Recommend gutters be installed.

Recommend downspouts be installed and extended away from foundation.

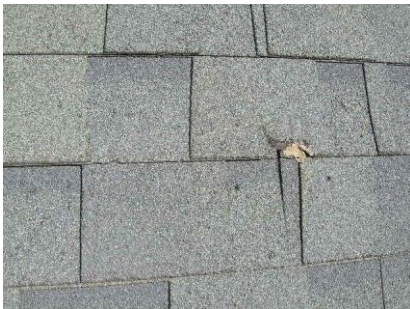
1

- Some shingles with minor damage were observed at the front to the right of the entry-way. (pic 1)
- Signs of previous shingle repair observed in front area.
- Plumbing vent pipe observed in the valley area of the roof on East side – this is an area where a leak could occur due to high water volume.(pic 2)
- Sample view of the West side roof (pic 3)
- Overall, the roof appears to be in satisfactory condition at this time. This is not a guarantee against leaks. For a guarantee, you would need to have a licensed roofing company perform a water-test and issue a roof certification
- Recommend a licensed roofing company for any repairs

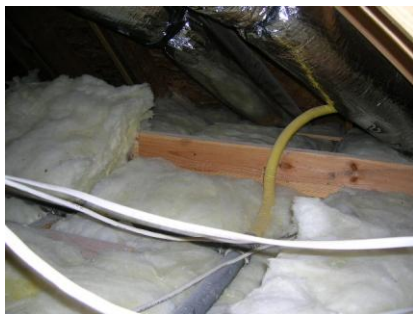
- Attic was entered at pull-down attic staircase and attic access door at game room on second floor.
- Several areas of the attic were not accessible due to personal items and heating/cooling equipment.
- Sample views of attic insulation in pull-down attic stairway access (pic 1 and 3) and half-door attic access off the 2nd floor game room (pic 2)

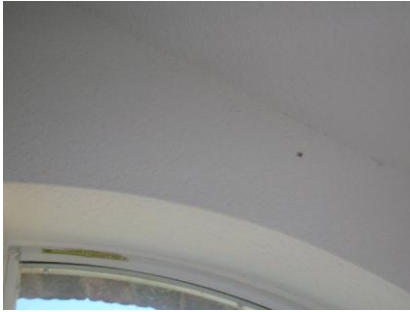
1

- Interior dry-wall walls have some nail pops throughout the house – cosmetic in nature. (pic 1)
- Caulking needed at exterior areas of garage doors and some exterior areas of windows throughout the house. (pic 2&3)

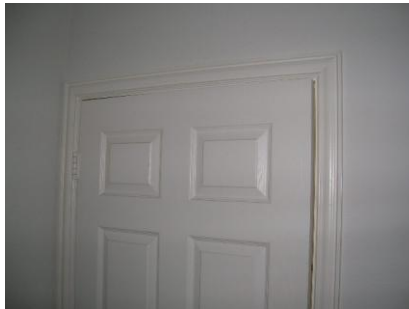
1

- Door rubbing at the top at second floor bathroom/ middle bedroom door. (pic 1)
- Recommend adding weather-stripping to front exterior door for a better seal.

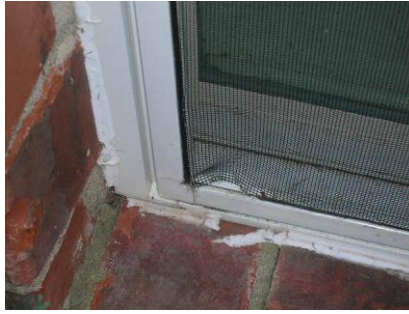
1

- Exterior window screen on East side of house has minor damage. (pic 1)

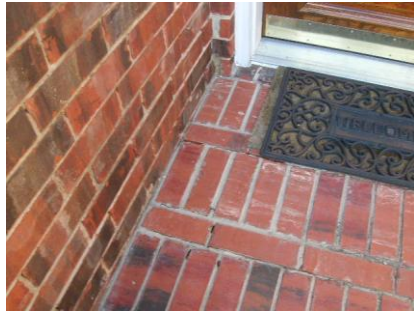
1

- Front brick patio has mortar separation and damage in several areas. (pic 1)

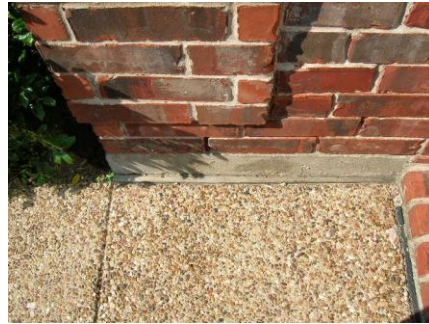
2

- There is wood expansion joint material in front patio walk-way area and sidewalk area in front of the house – this material is conducive to rotting and susceptible to wood-destroying insects. (pic 2)
- Recommend further evaluations and repair by a specialist

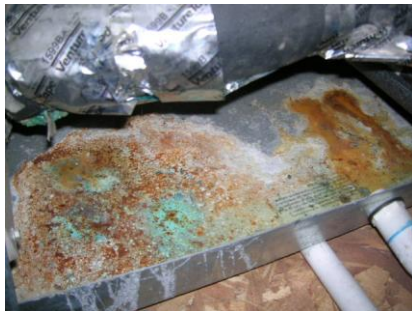
1

- Observed rust and corrosion in pans underneath each unit in attic. (pic 1)
- Insulation on suction line is present but not completely secured at the exterior.(pic 2)
- Recommend an HVAC specialist for service and evaluation.
- Drain pan auxiliary lines appear to terminate at exterior at soffit area above 2nd floor middle bedroom window.

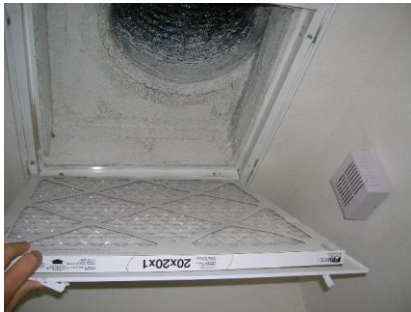
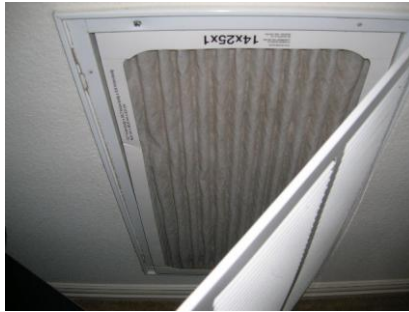
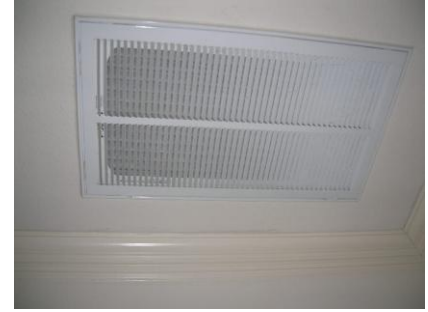
- Air filters are located at: 1st floor m/bedroom ceiling, 2nd floor hallway ceiling, 2nd floor game room wall. (pics 1-3)
- Dirty air filters need to be replaced for maximum efficiency.
- Recommend an HVAC specialist for regular service and repairs.

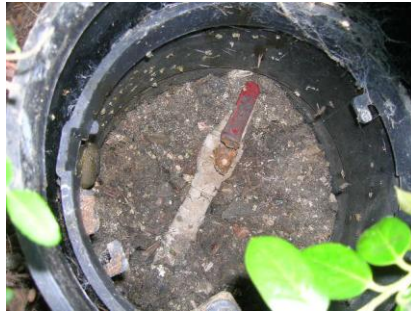
1

- Sample view of main shut-off valve in front shrub area. The shut-off handle is rusted and appears broken. The valve was viewed only and not operated. (pic 1)
- Recommend a plumber for further evaluation and repair.

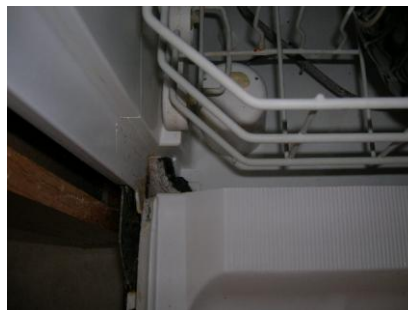
- Rust and corrosion was observed near the hinges of the dishwasher and various areas of the dishwasher racks. (pic 1)
- Dishwasher was run through a full cycle with no leaks observed.

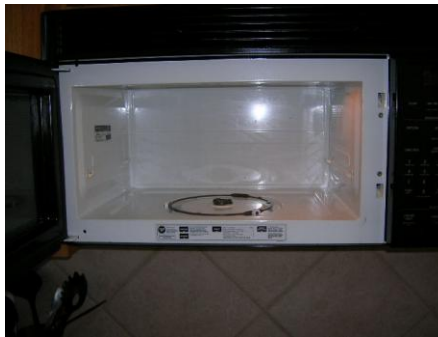
E. Microwave Oven *Comments:* Turn-table inside the microwave is missing. (pic 1)
