Systematic Home Inspections, PLLC

PROPERTY INSPECTION REPORT

Concerning: Confidential - McKinney, TX 75069

9/1/2010

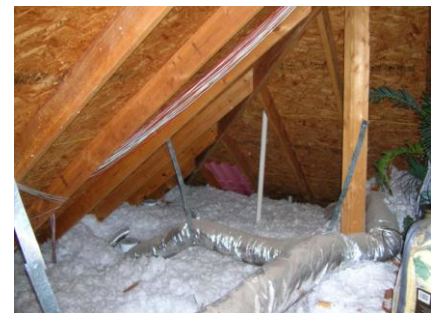
3

- Attic was entered at pull-down attic staircase and attic access door at game room on second floor.
- Several areas of the attic were not accessible due to personal items and heating/cooling equipment.
- Sample views of attic insulation in pull-down attic stairway access (pic 1 and 3) and half-door attic access off the 2nd floor game room (pic 2)

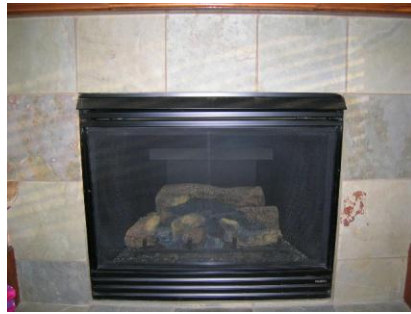
- Sample view of *Heatilator* gas fireplace insert (pic 1)
- Fireplace pilot was lit with igniter button and flame responded to controls.

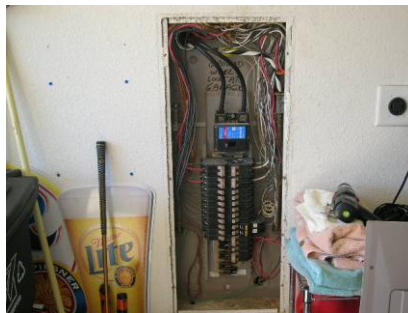
1

- Sample view of 200 amp electrical panel in garage with panel removed. (pic 1)

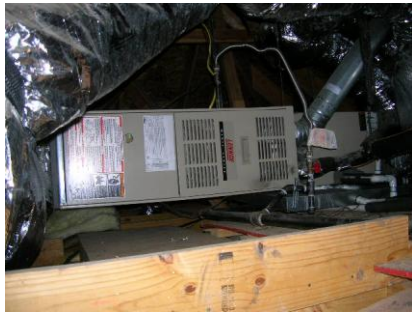
1

- Furnace unit was tested and operated in heat mode. Burners were observed with a steady blue flame.
- No damage to heating chamber was observed.
- Furnace unit on left operated from second floor hall thermostat and services 2nd floor. Furnace unit on right operated from first floor thermostat at base of stairway and services 1st floor.
- Sample views of attic furnaces – Unit on left (pic 1) Unit on right (pic 2)

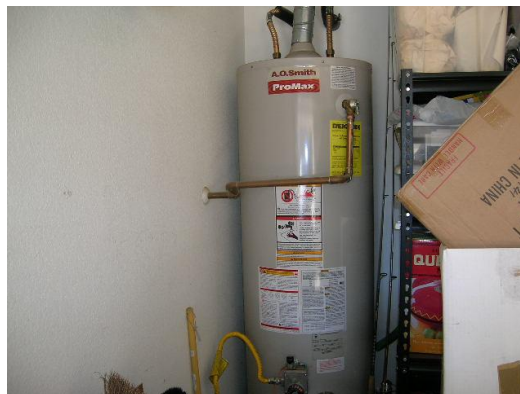
- TPR overflow valve is routed to the exterior and terminates on West side of house near the ground
- Sample view of water heater in the garage (pic 1)

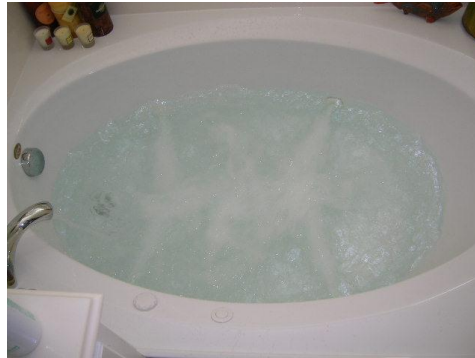
- There is no readily accessible cover to view the pump motor.
- All jets functioning and controls operating as intended.
- Sample view of whirlpool tub operating (pic 1)

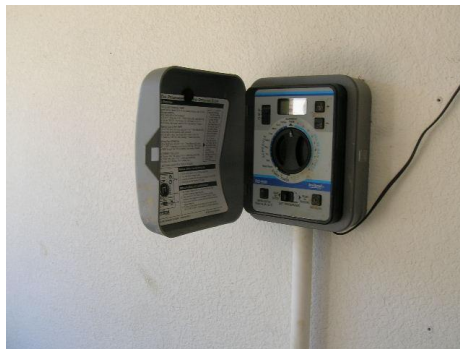
- Sample view of sprinkler control box. (pic 1)
- Some sprinkler heads in the front yard and front shrub area need minor adjustment.
- Damaged sprinkler heads located along front sidewalk.
- Recommend a licensed irrigation company for further evaluations.

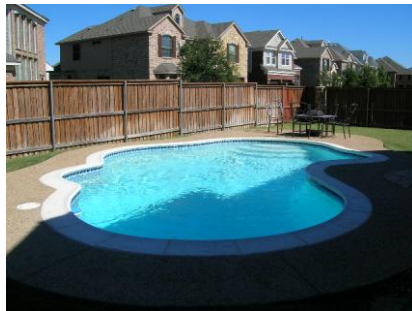
1

- Sample view of pool (pic 1)
- Sample view of pump motor/filter cartridge (pic 2)
- Pool vacuum present was manual type, responded to controls when connected.
- Pump motor responds to controls
- All jets appear to be functioning
- Pump motor grounding wire observed
- Pool tiles tight to pool wall
- Skimmer basket in place
- Recommend a pool company for further evaluations of underwater pool coating condition.
